# **CASTING BASIN GATE MAINTENTANCE RECORDS**

CYCLE 6

# Kiewit-General Inspection Report

**PROJECT:** SR 520 PONTOONS

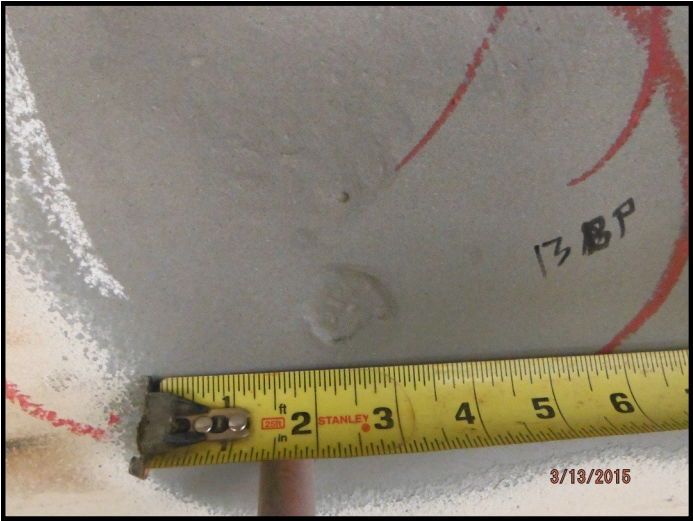
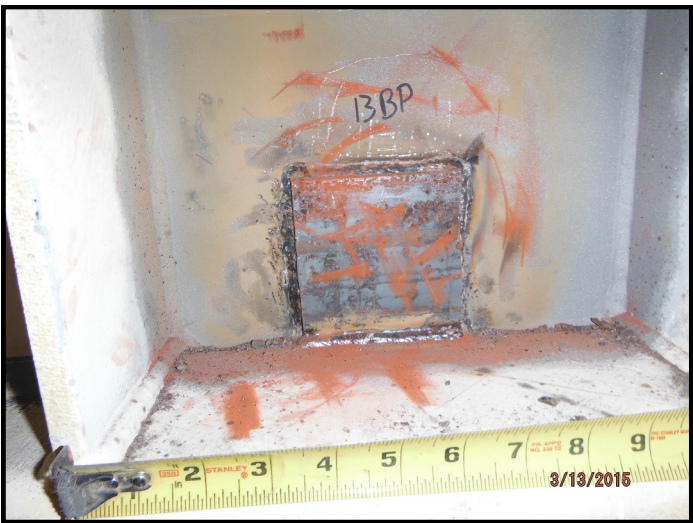
13B P

54" before Grid 3T: 1" diameter X 1/8" pit

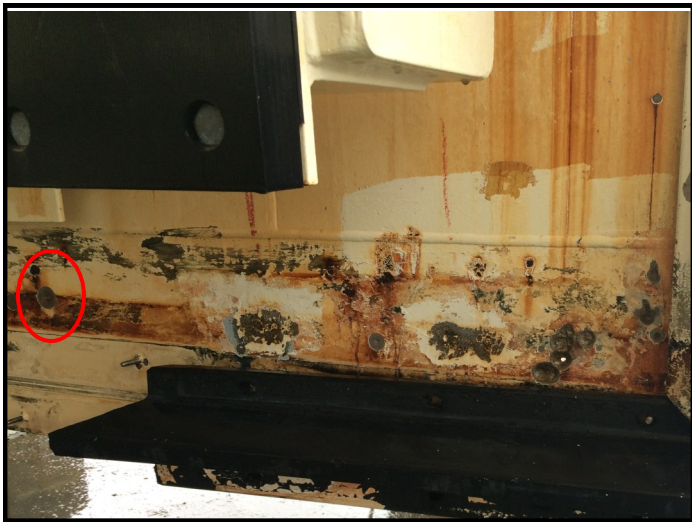
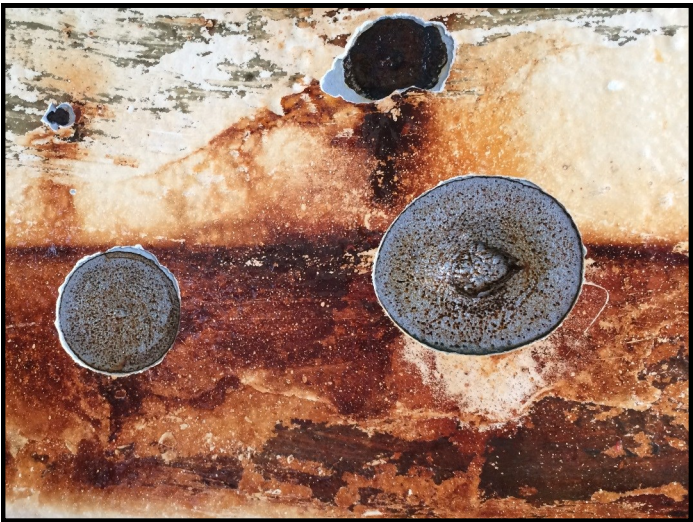
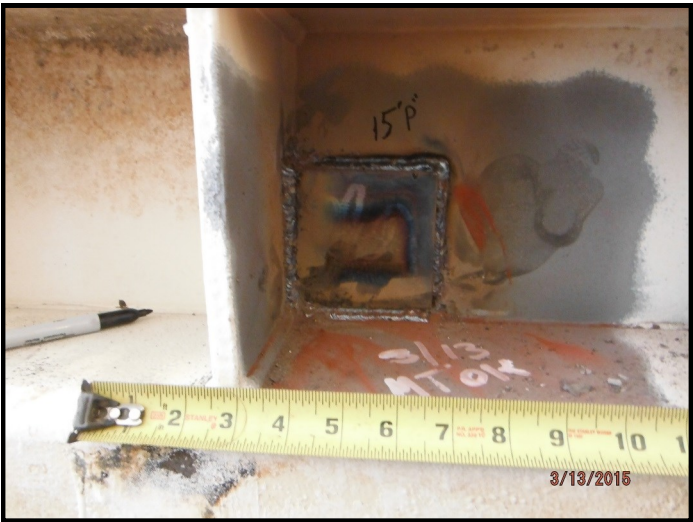
15 P  
Grid 1.2T: 1/2" diameter X 1/16" pit

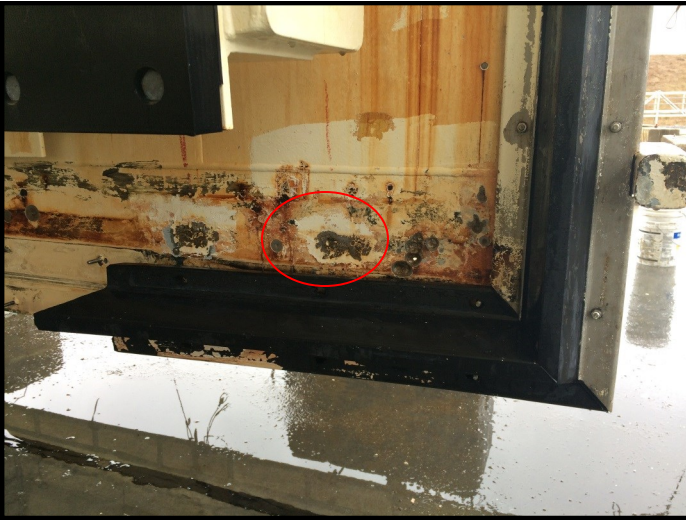
17 F

18" after Grid 1T: 2EA 1/8" diameter X 1/16" pits, 2EA existing repairs with 1/16" pits

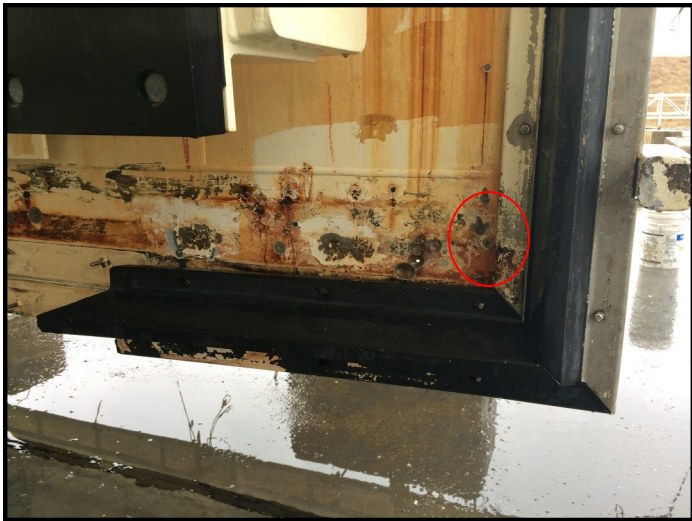
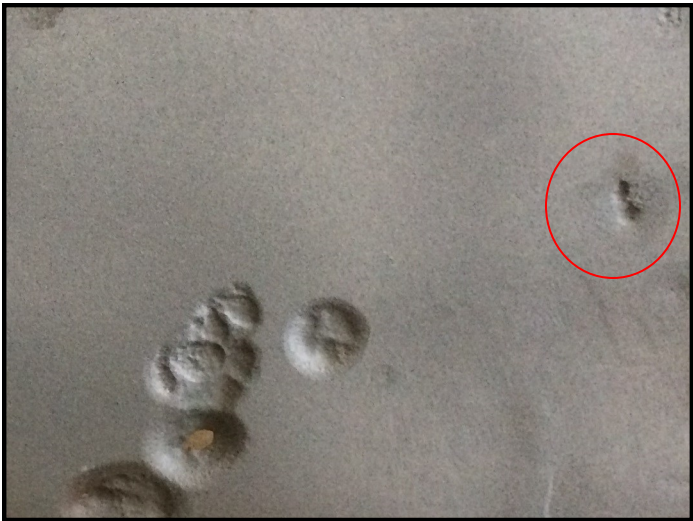
18 F

6" after Grid 1T: 1/4" diameter x 1/16" pit

NO PLATE REQUIRED

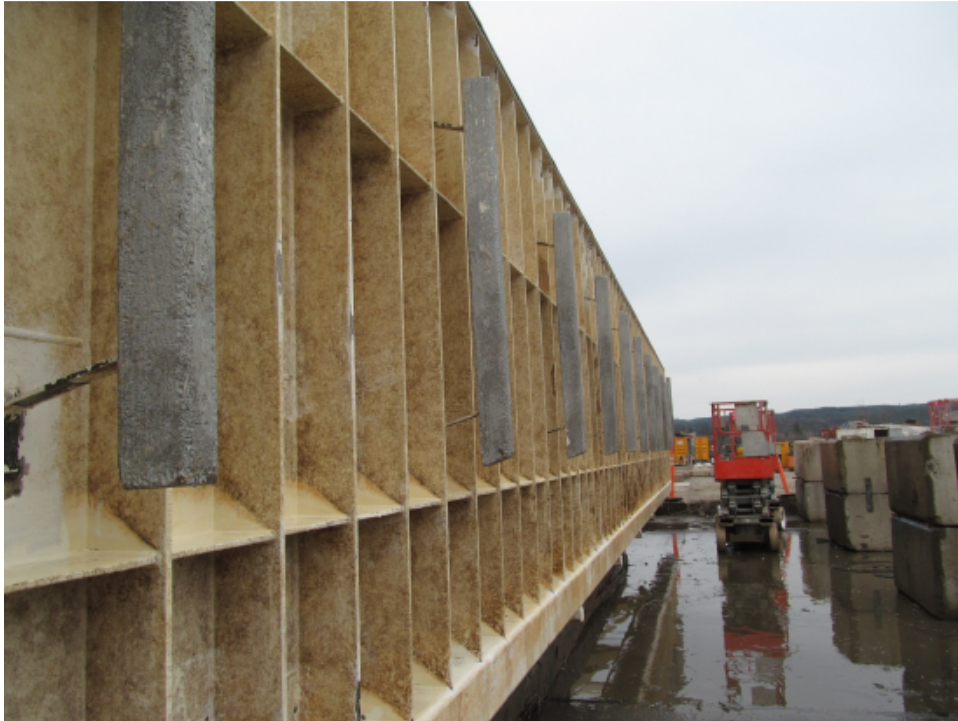
**Photo 1: Waterside Gate Barrier Wall**

2. The water-side face showed little rusting and minor damaged paint in random spot locations, see **Photo 1**. The anodes installed during the Cycle 5 float out appear to be protecting the wall. KG was preparing and painting the damaged coating locations.

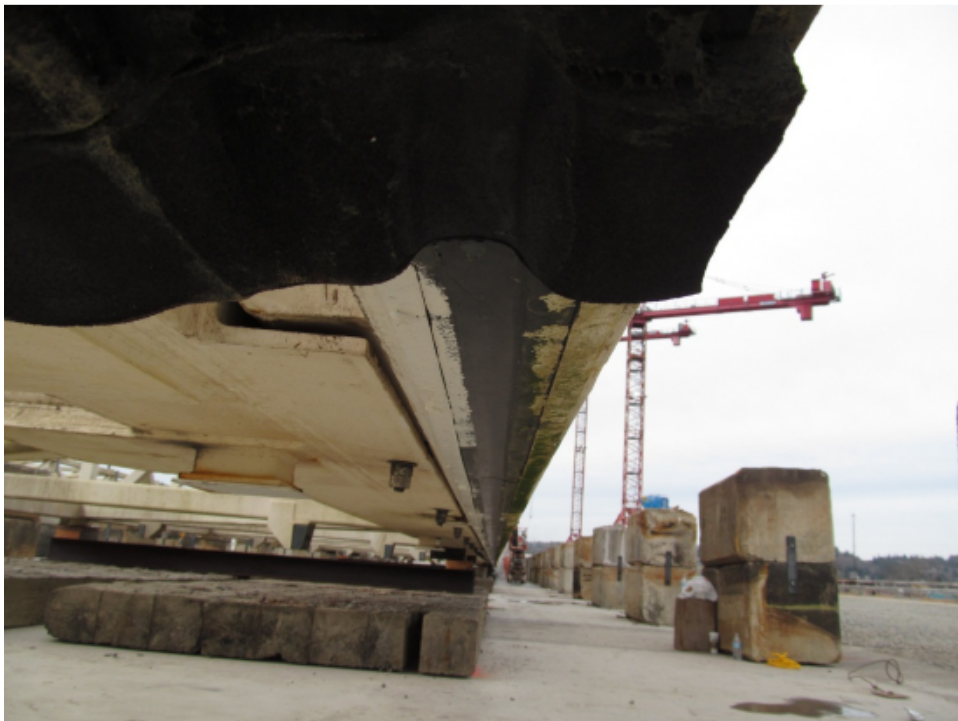
**Photo 2: Dimpled Neoprene Pad**

6. The continuous neoprene bearing pads that were added to the seal at the bottom edges were slightly dimpled but still serviceable, see **Photo 2**.
7. The barrier wall bolts did not appear to be deflected to a greater extent than Cycle 4 or 5. All remaining bolts were still in place.

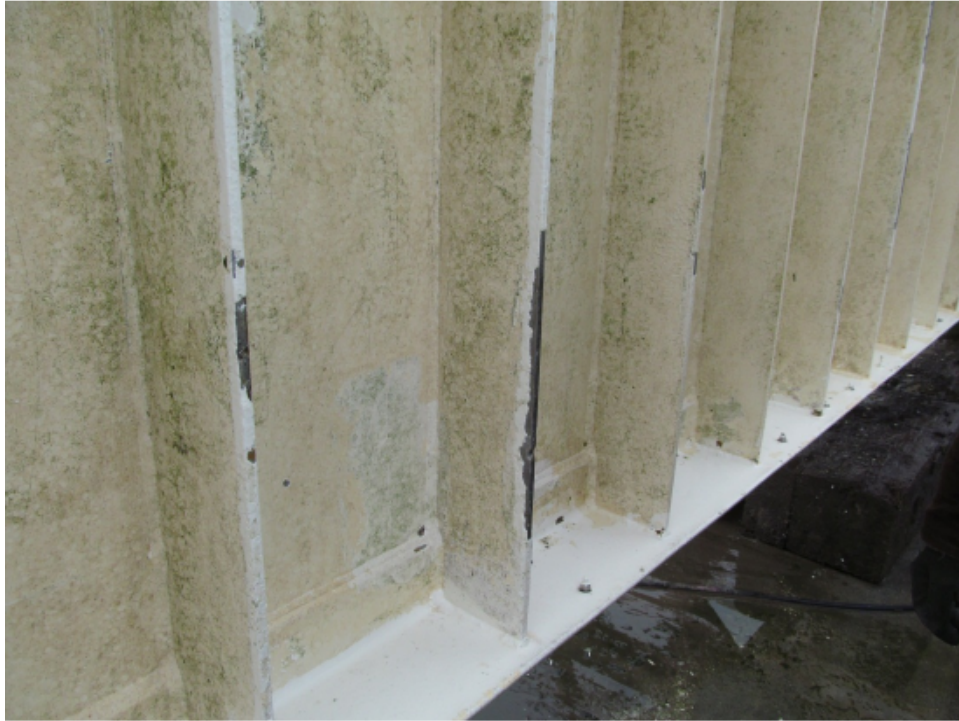
**Photo 3: Gouge in Barrier Wall Stiffener**

9. Barrier wall stiffeners showed local gouges at the stiffener edge. These gouges are typically 1/16" to 3/16" deep, and 1/2" to 1" tall, see **Photo 3**. The gouges may be from overgrinding during paint repair, however did not appear to be significantly worse than cycle 4 and 5.

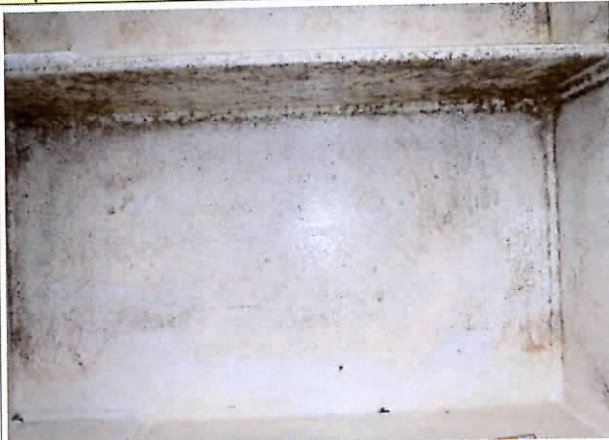
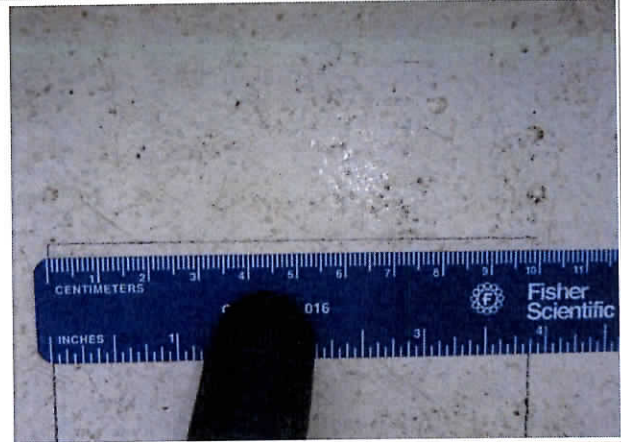
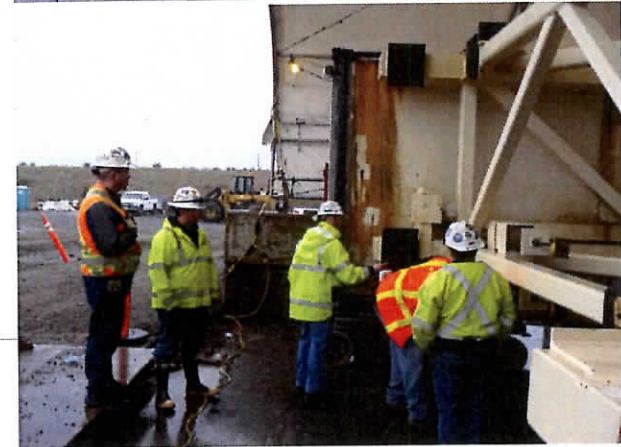
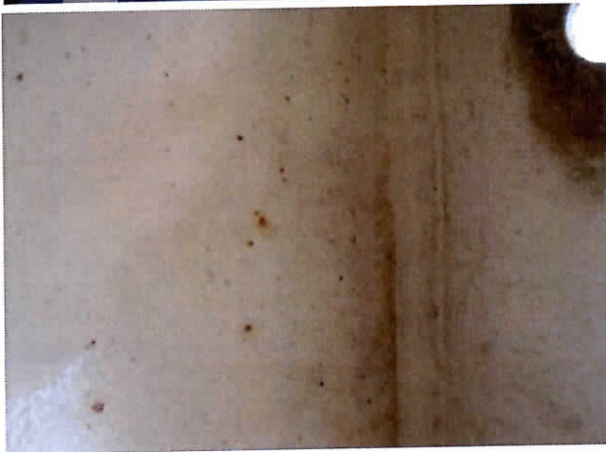
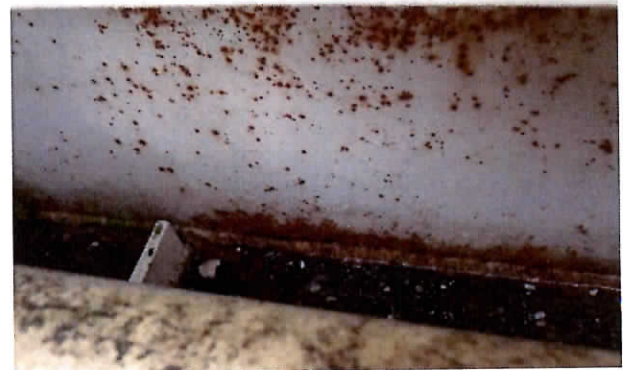
TOP SIX: Typical coating failures, ferrous iron ion testing

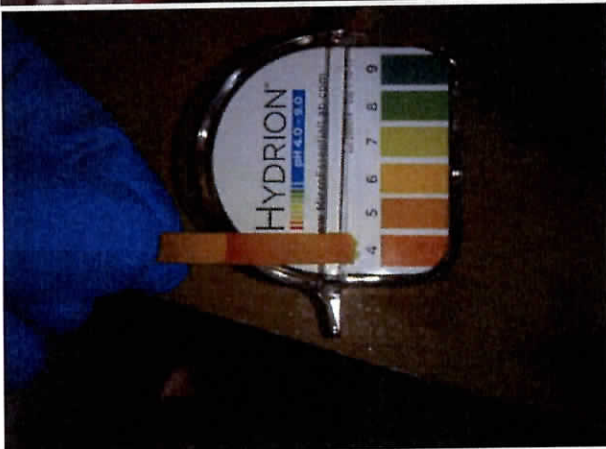
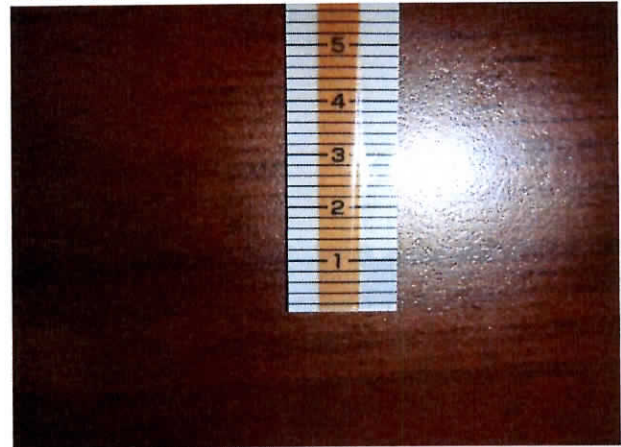
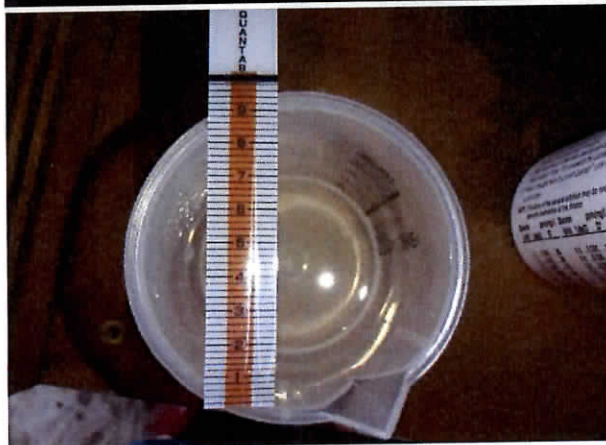
TOP SIX: Chloride and nitrite testing, T1/T2/T3 sections of gate

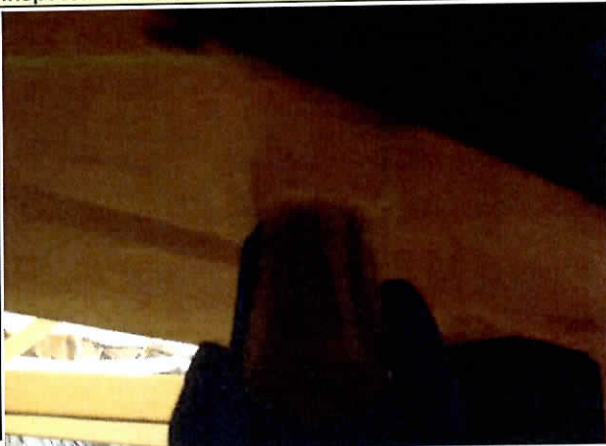
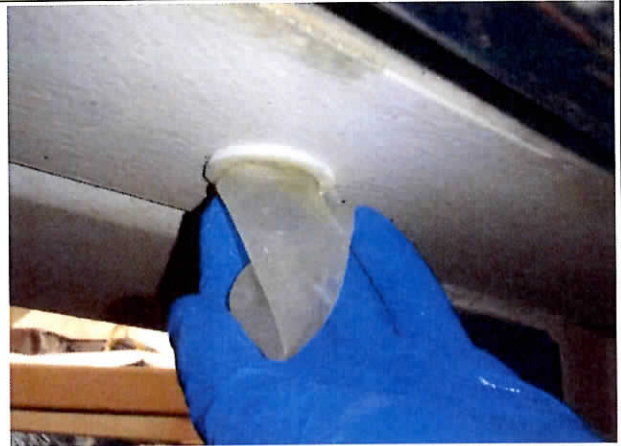
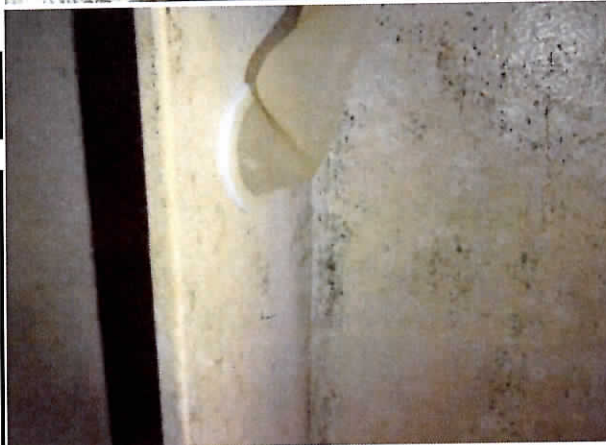
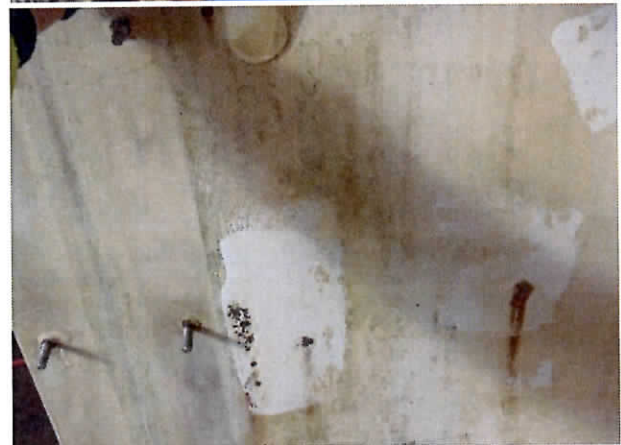
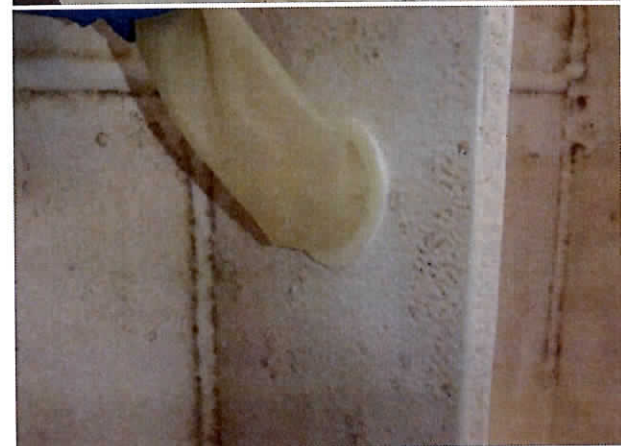
TOP SIX: Sulfate and chloride sleeve testing, casting basin gate

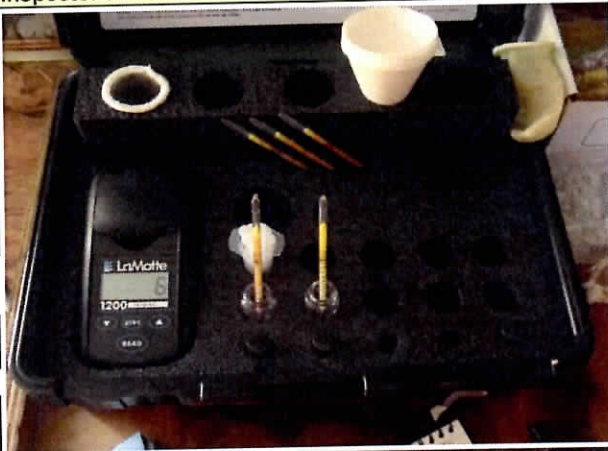
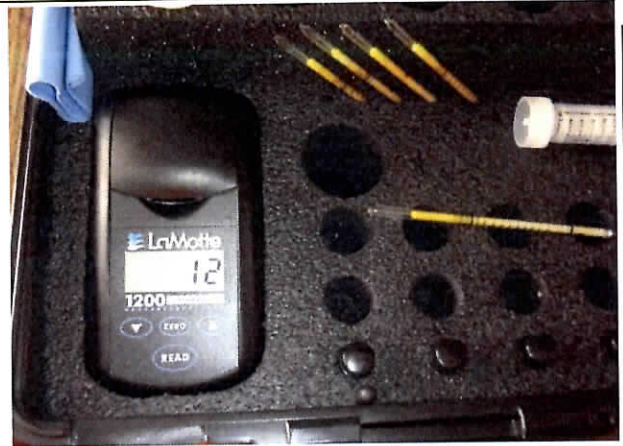
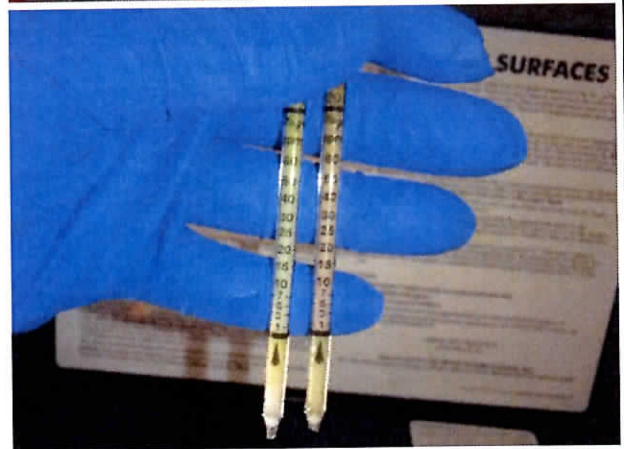
TOP SIX: Sulfate and chloride results, casting basin gate

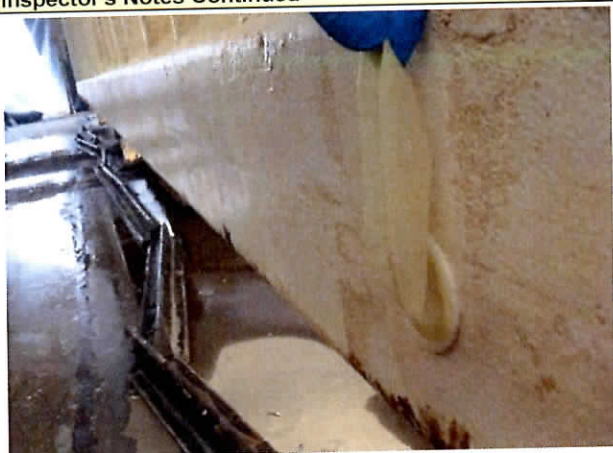
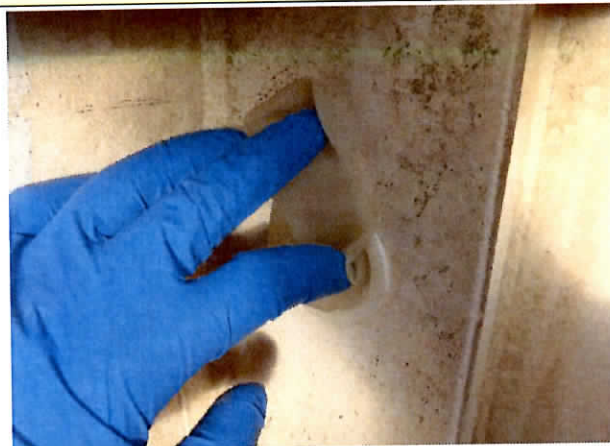
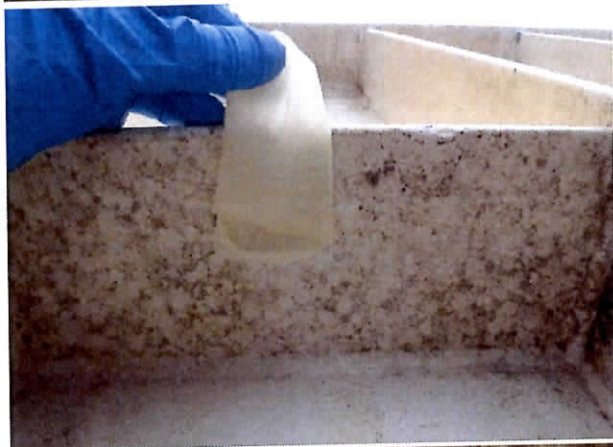
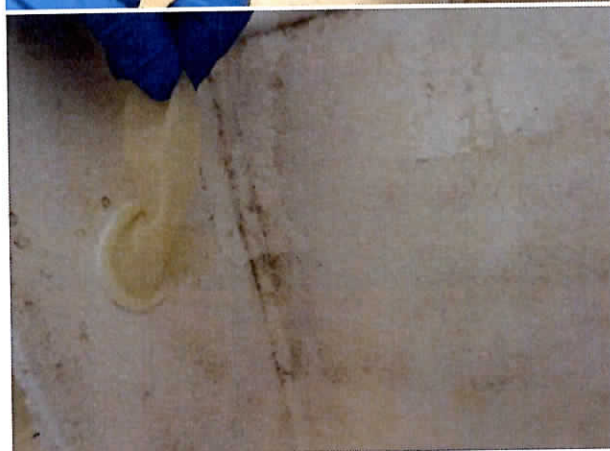
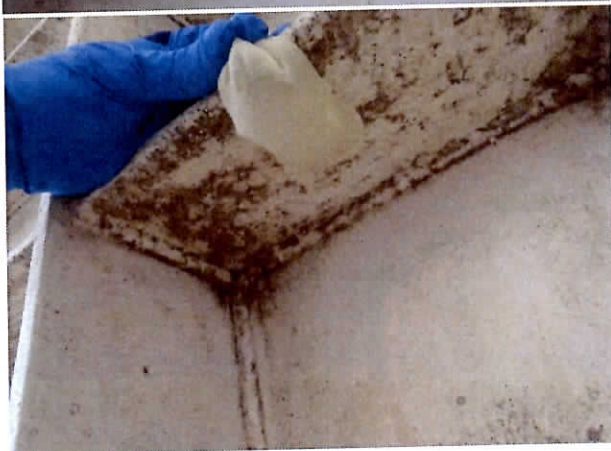
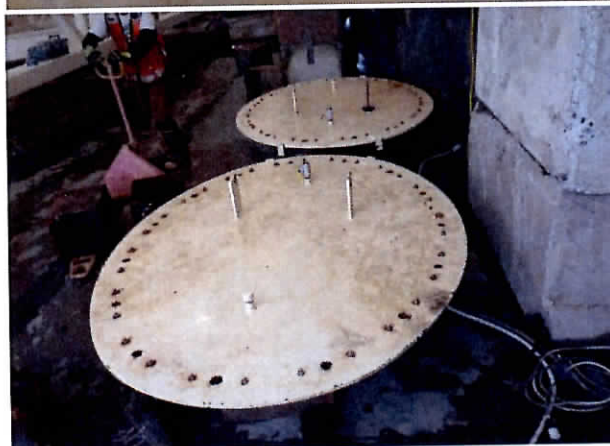
TOP SIX: Sulfate and chloride sleeve testing, casting basin gate

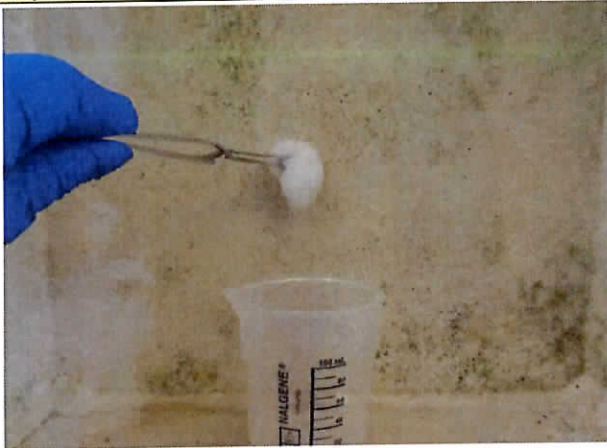
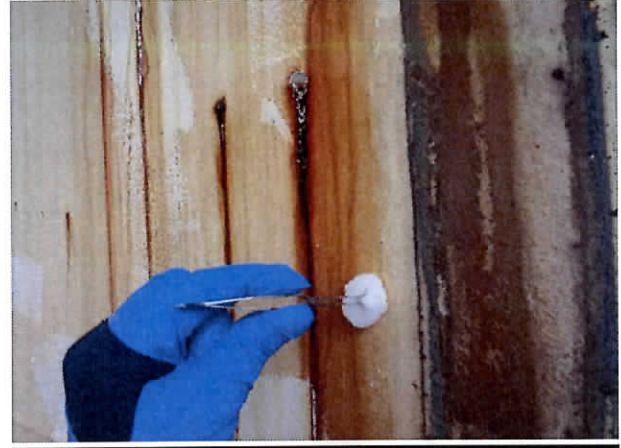
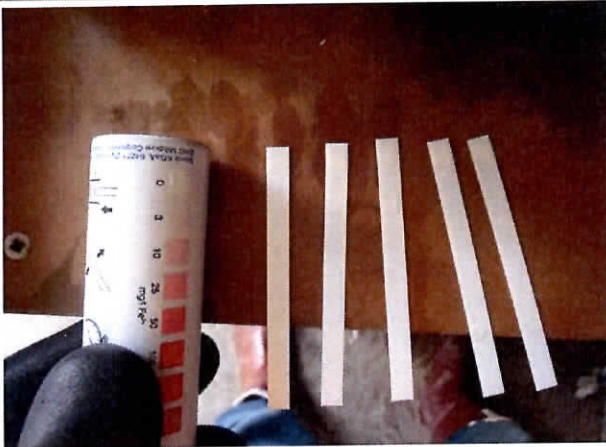
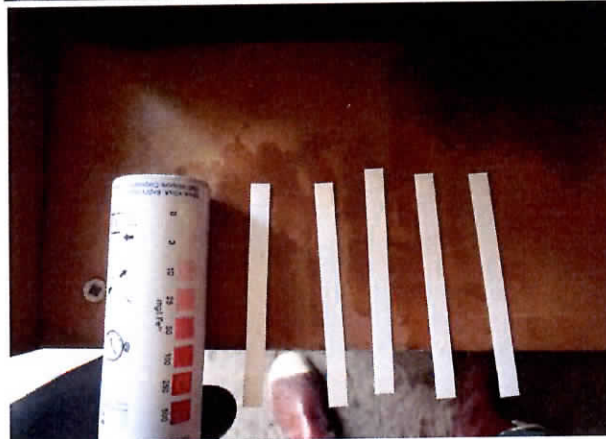
TOP SIX: KTA FIL test results, blast medium, basin gate

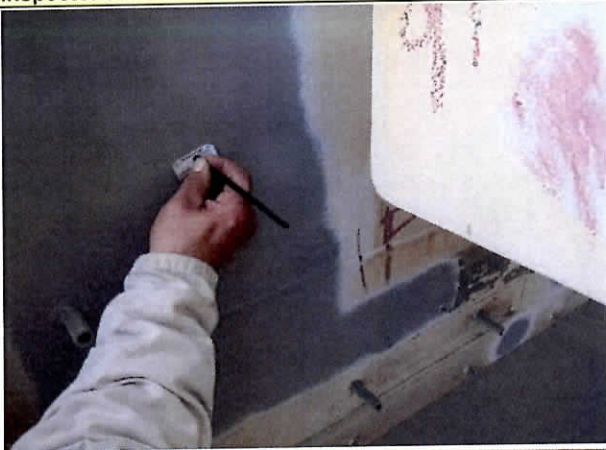
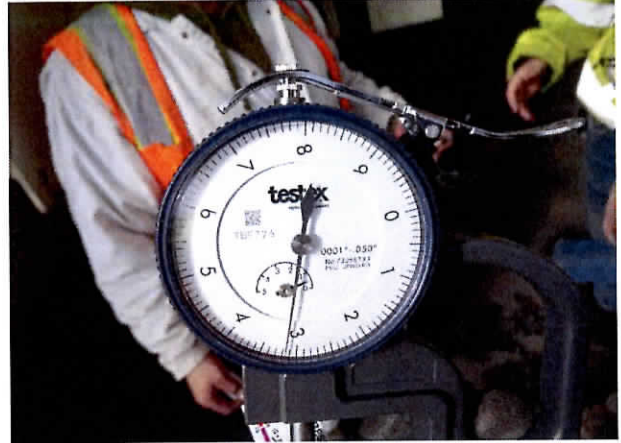
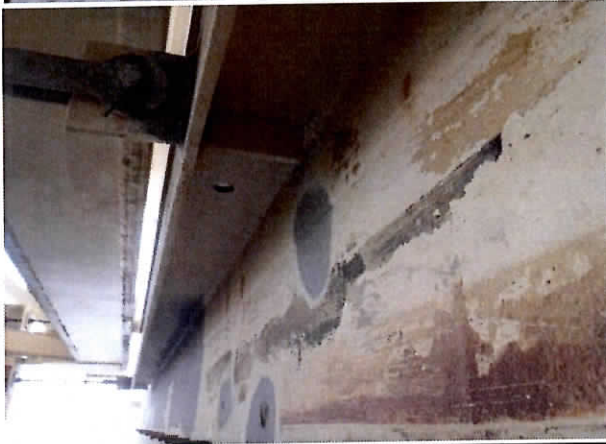
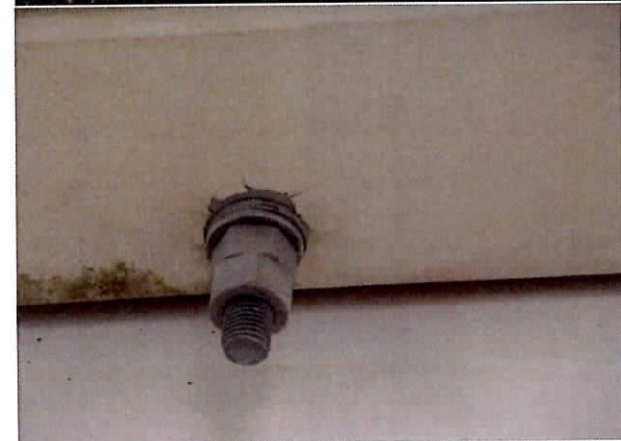
TOP SIX: Surface anchor profile, repair profile, noted areas of blasting and coatings failure

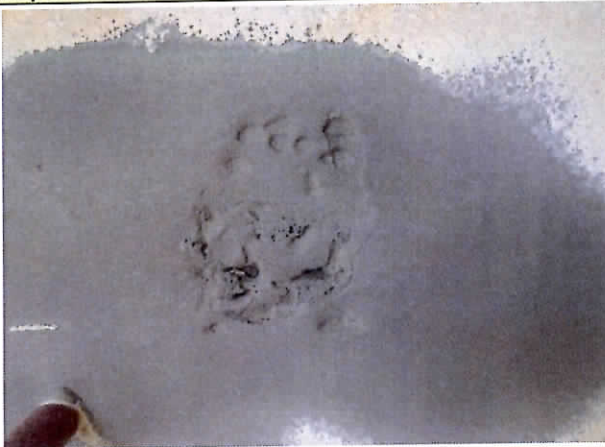
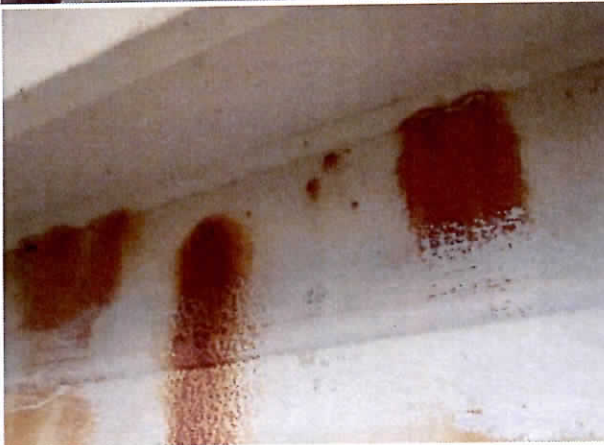
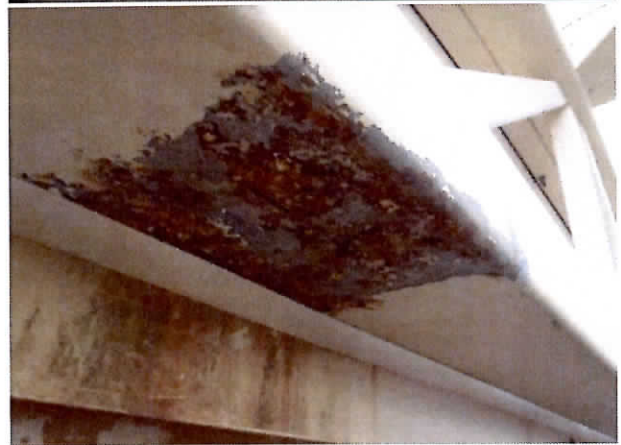
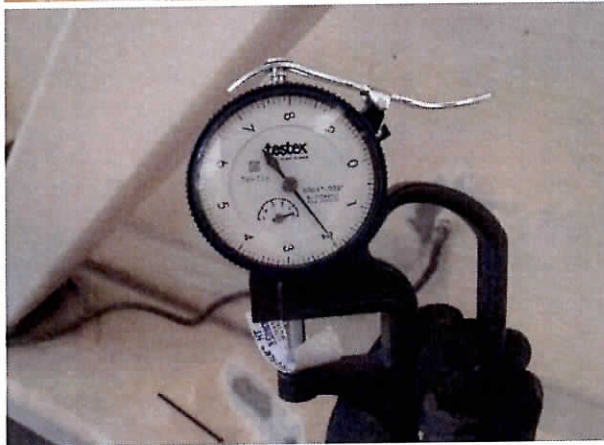
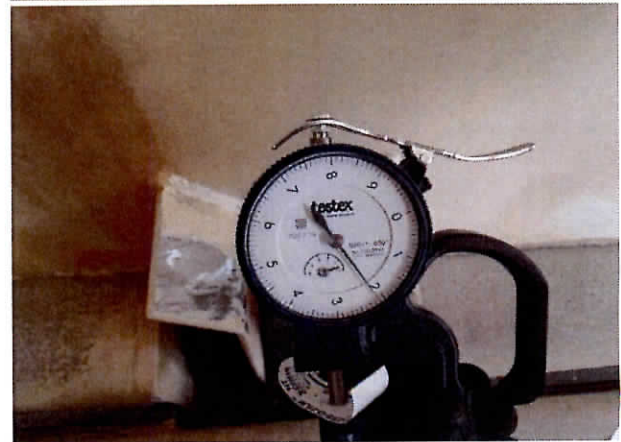
IDR Sheet	QA Key Personnel Function	Date
Sheet 9 of 9	Structural Inspector	Thursday, March 12, 2015
Inspector	IDR Report #	
Doug Brinius	3/12/2015 DB	
Inspector's Notes Continued

TOP SIX: Surface profile, repair profile, noted areas requiring more abrasive

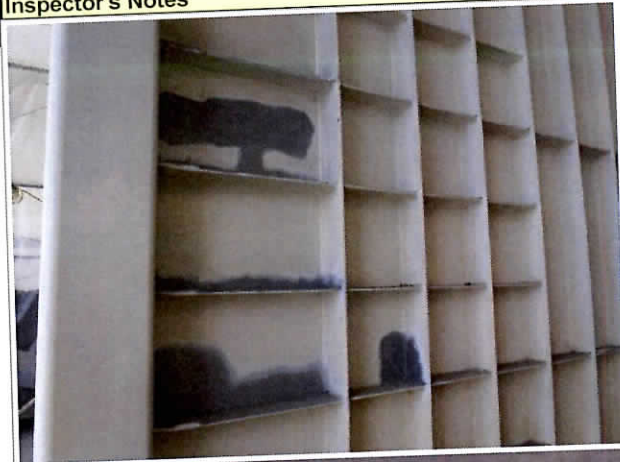
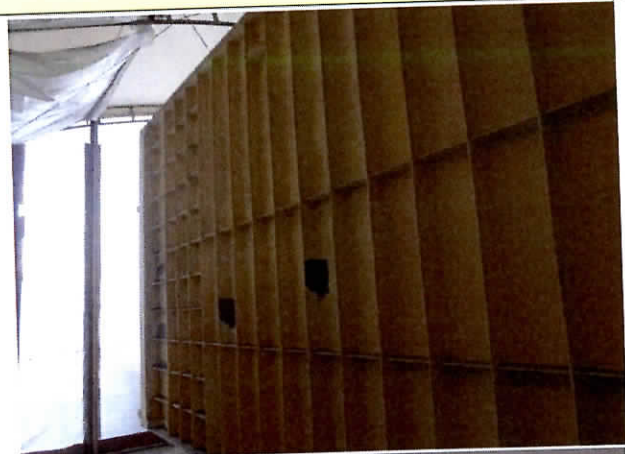
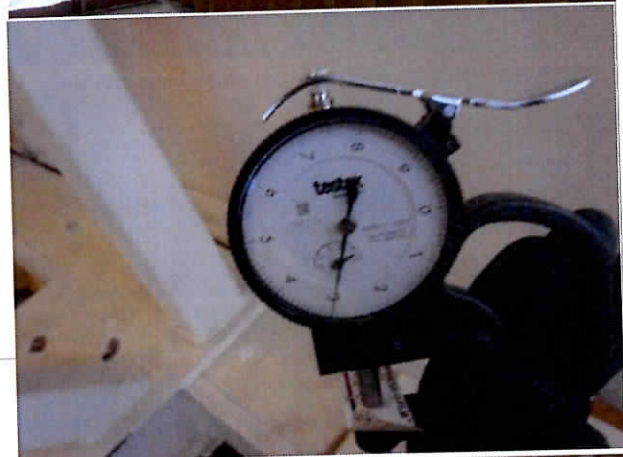
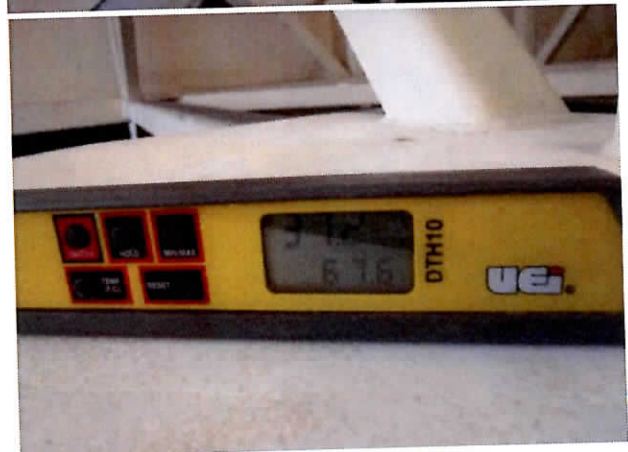
IDR Sheet Sheet 3 of 13	QA Key Personnel Function Structural Inspector	Date Friday, March 13, 2015
Inspector Doug Brinius		IDR Report # 3/13/2015 DB
Inspector's Notes

TOP SIX: Atmospheric condions in tents 1 and 2, anchor profile testing, blast removal of failing coatings

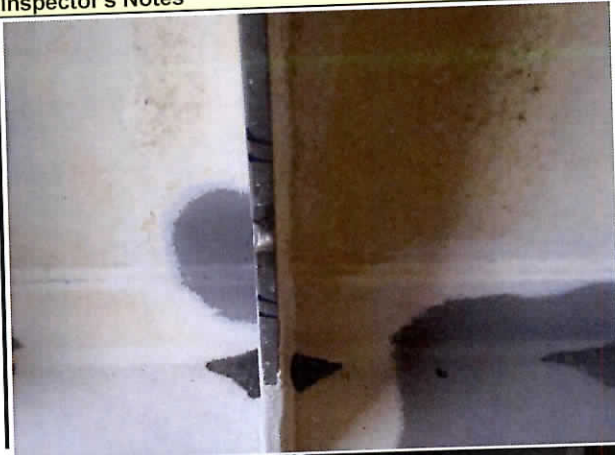
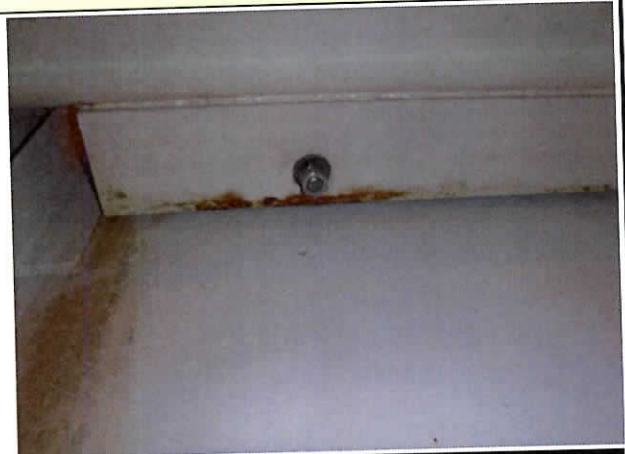
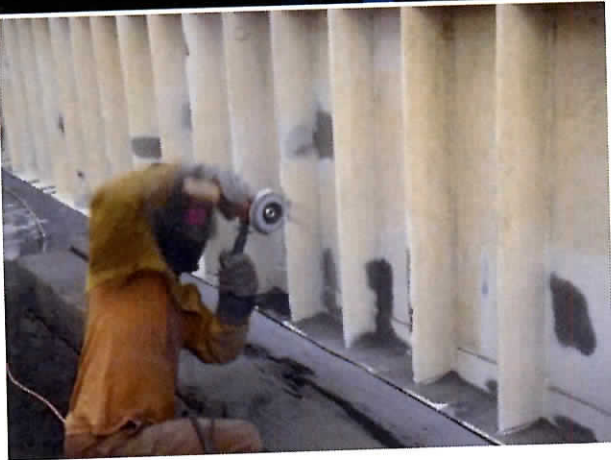
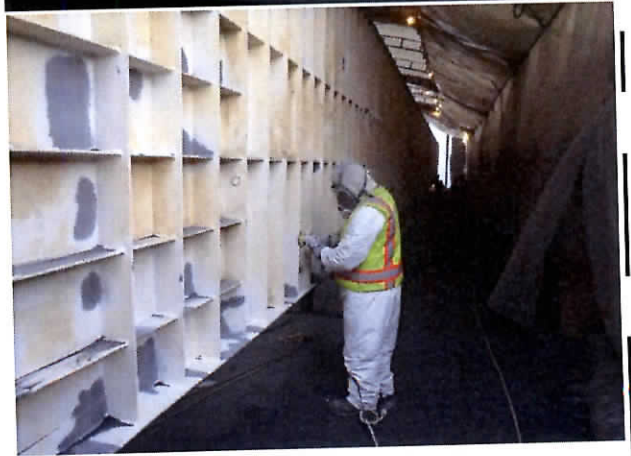
IDR Sheet	QA Key Personnel Function	Date
Sheet 4 of 13	Structural Inspector	Friday, March 13, 2015
Inspector Doug Brinius	IDR Report # 3/13/2015 DB	
Inspector's Notes

TOP SIX: Substrate repairs, anchor profile testing, blast removal of failing coatings

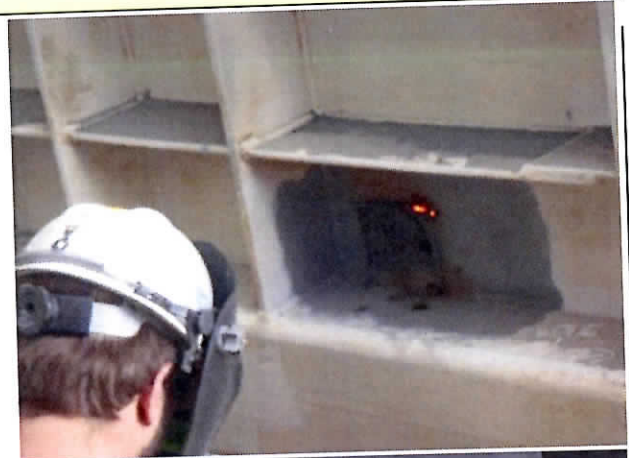
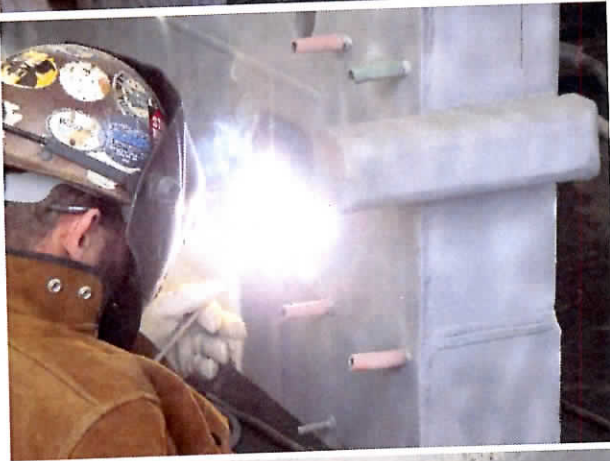
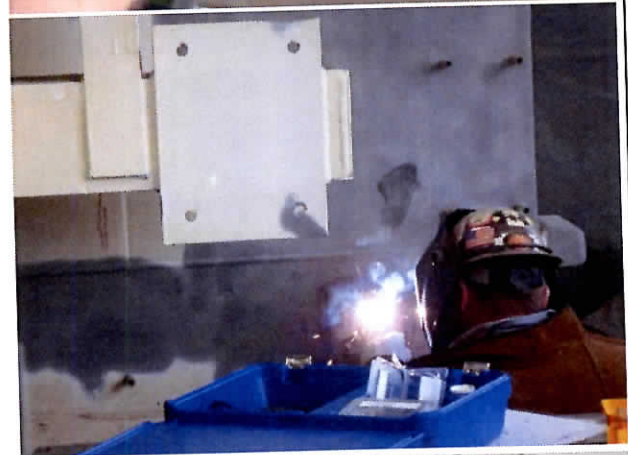
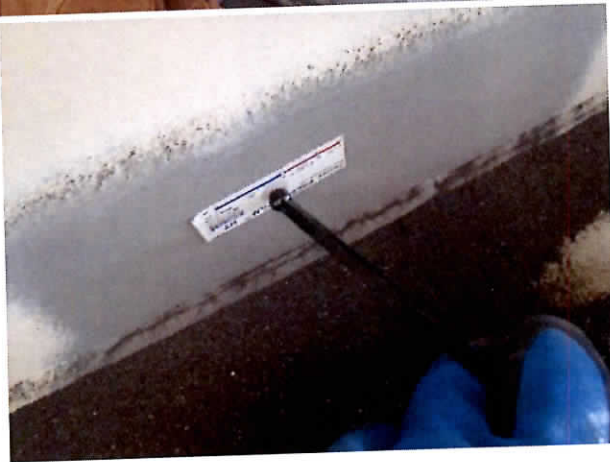
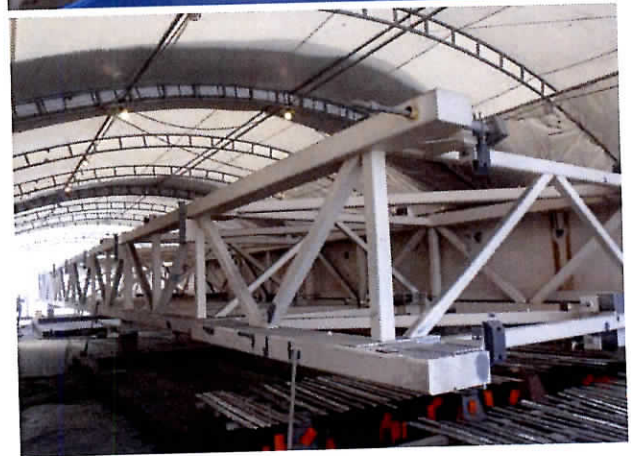
IDR Sheet	QA Key Personnel Function	Date
Sheet 5 of 13	Structural Inspector	Friday, March 13, 2015
Inspector Doug Brinius	IDR Report # 3/13/2015 DB	
Inspector's Notes Continued

TOP SIX: Substrate repairs, anchor profile testing, blast removal of failing coatings

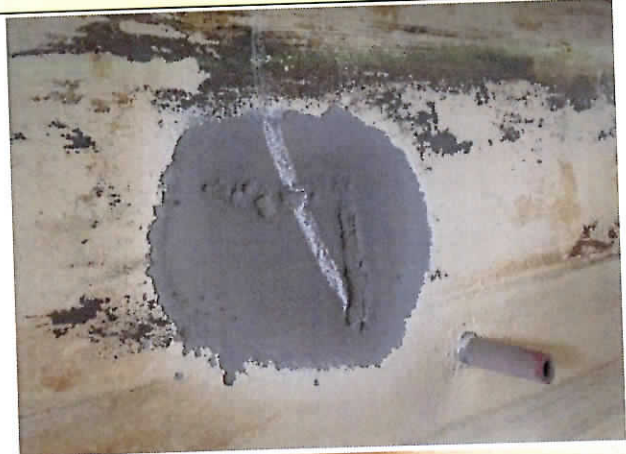
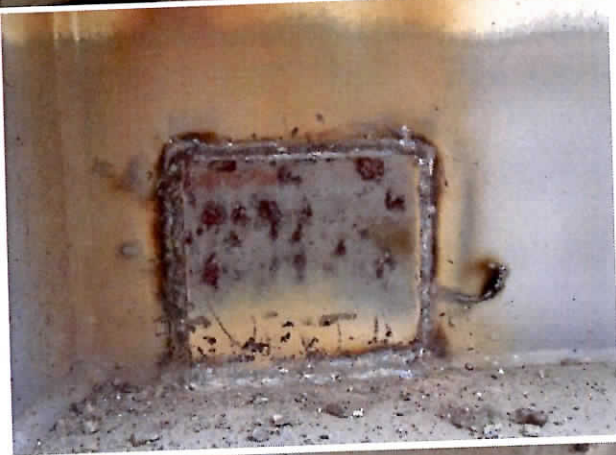
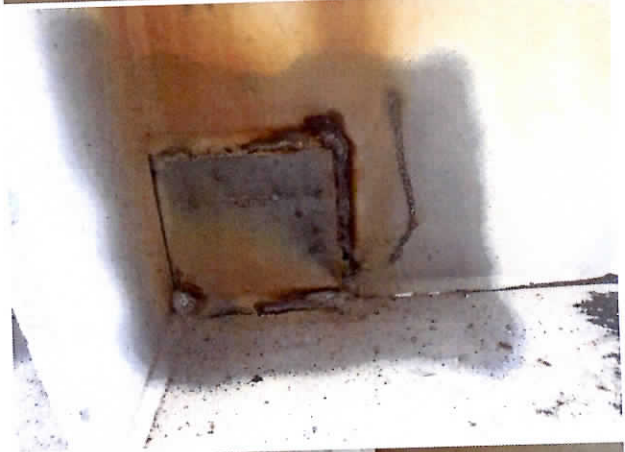
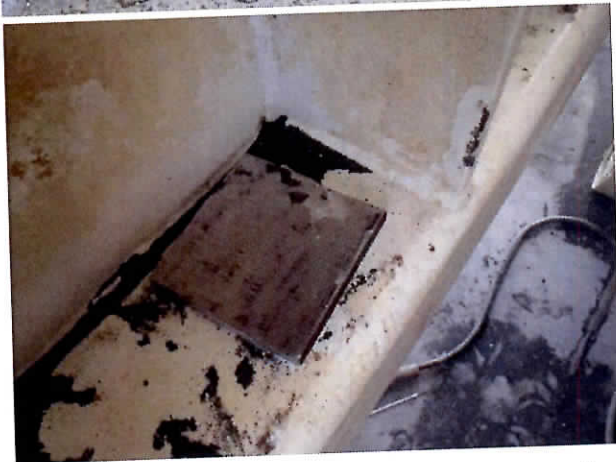
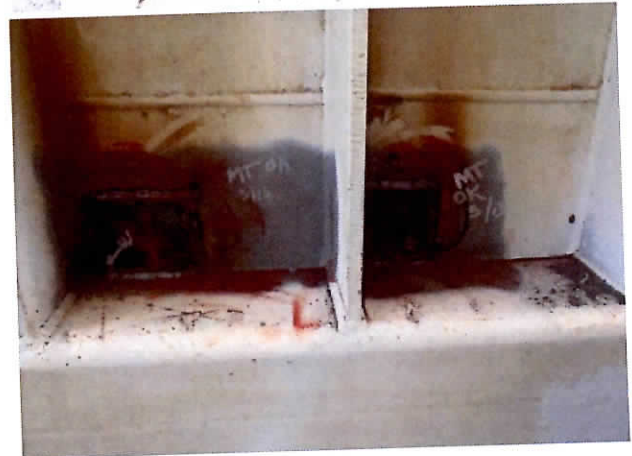
IDR Sheet Sheet 6 of 13	QA Key Personnel Function Structural Inspector	Date Friday, March 13, 2015
Inspector Doug Brinius		IDR Report # 3/13/2015 DB
Inspector's Notes Continued

TOP SIX: Repairs of truss 1, casting basin gate

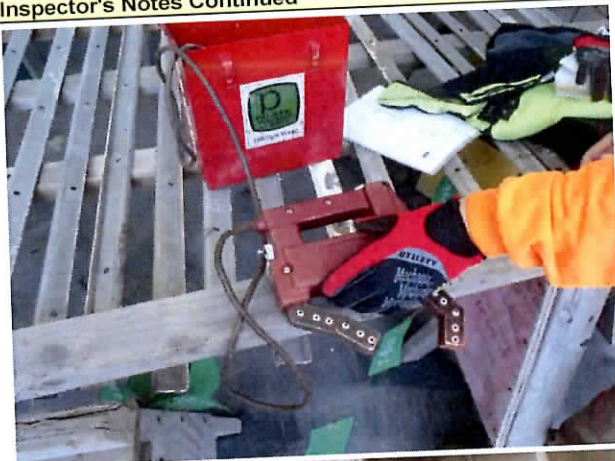
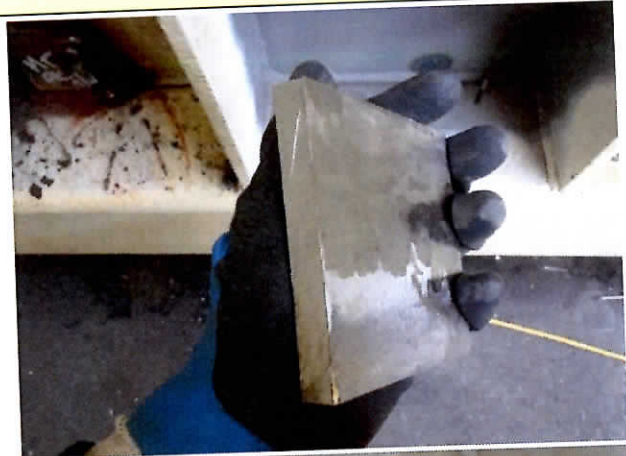
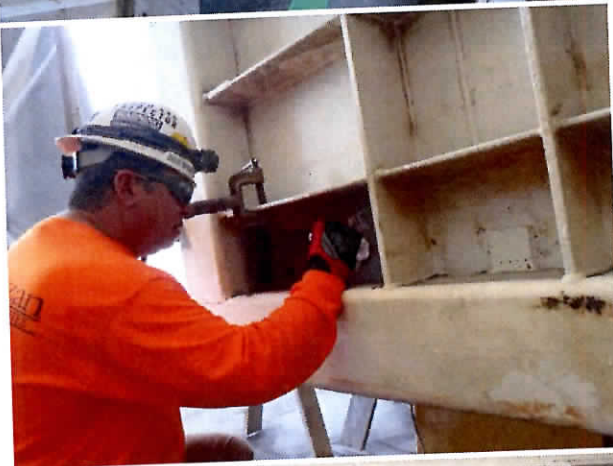
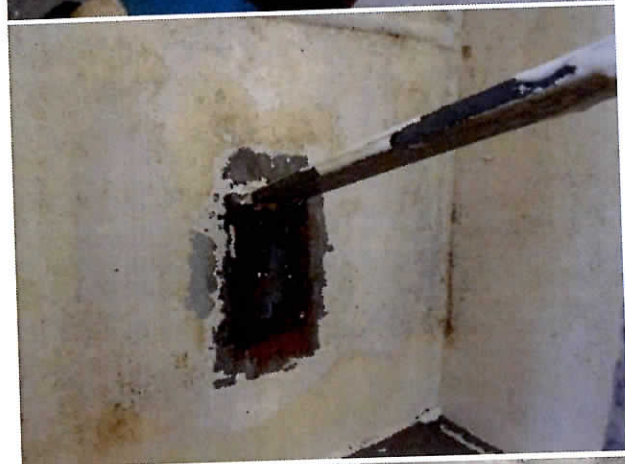
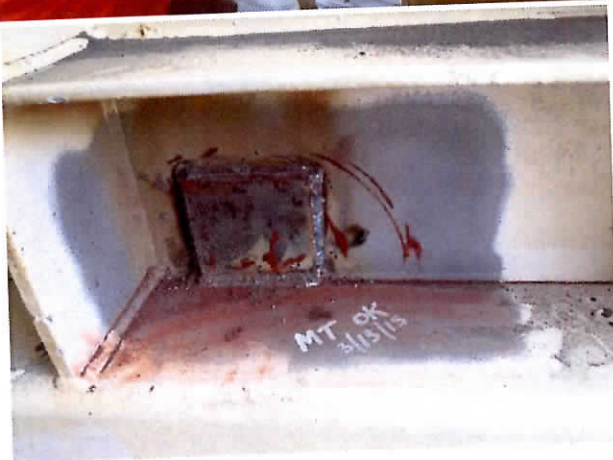
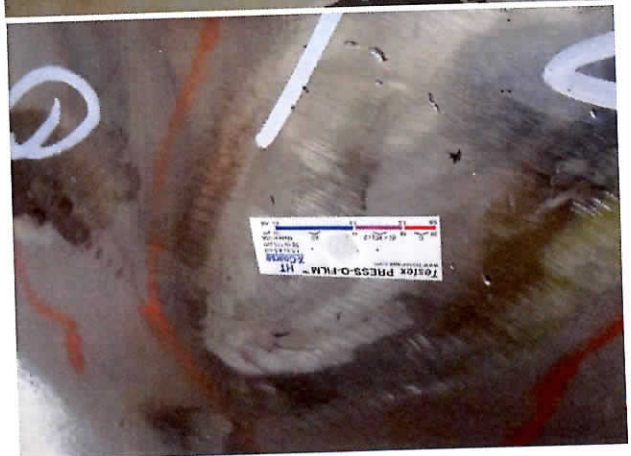
IDR Sheet Sheet 7 of 13	QA Key Personnel Function Structural Inspector	Date Friday, March 13, 2015
Inspector Doug Brinius		IDR Report # 3/13/2015 DB
Inspector's Notes Continued

TOP SIX: Mag particle testing, weld repairs, anchor profile, Truss 1
